DEPARTMENT OF TRANSPORTATION

Quality Assurance and Source Inspection

Contract #: 04-0120F4Cty: SF/ALA Rte: 80 PM: 13.2/13.9File #: 69.28**WELDING INSPECTION REPORT****Resident Engineer:** Pursell, Gary**Address:** 333 Burma Road**City:** Oakland, CA 94607**Report No:** WIR-015241**Date Inspected:** 24-Jun-2010**Project Name:** SAS Superstructure**OSM Arrival Time:** 700**Prime Contractor:** American Bridge/Fluor Enterprises, a JV**OSM Departure Time:** 1900**Contractor:** Zhenhua Port Machinery Company, Ltd (ZPMC), Changxing Island **Location:** Shanghai, China**CWI Name:** Li Yan Hua**CWI Present:** Yes No**Inspected CWI report:** Yes No N/A**Rod Oven in Use:** Yes No N/A**Electrode to specification:** Yes No N/A**Weld Procedures Followed:** Yes No N/A**Qualified Welders:** Yes No N/A**Verified Joint Fit-up:** Yes No N/A**Approved Drawings:** Yes No N/A**Approved WPS:** Yes No N/A**Delayed / Cancelled:** Yes No N/A**Bridge No:** 34-0006**Component:** OBG**Summary of Items Observed:**

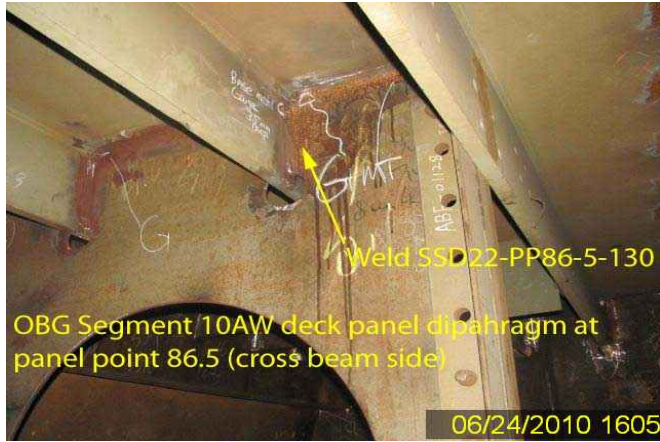
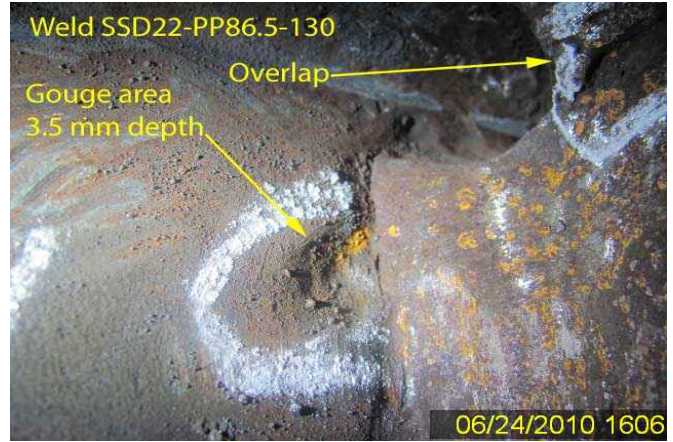
This QA Inspector performed random visual inspection of OBG segment 10AW interior surface. Several areas of base material and welds were covered by debris and required cleaning prior to visual inspection. Areas requiring repair were marked and shown to ZPMC and ABF QC for repair. Please see attached photographs below for additional information.
